SBB – Collision at Rafz – Two Views of North East End of Station

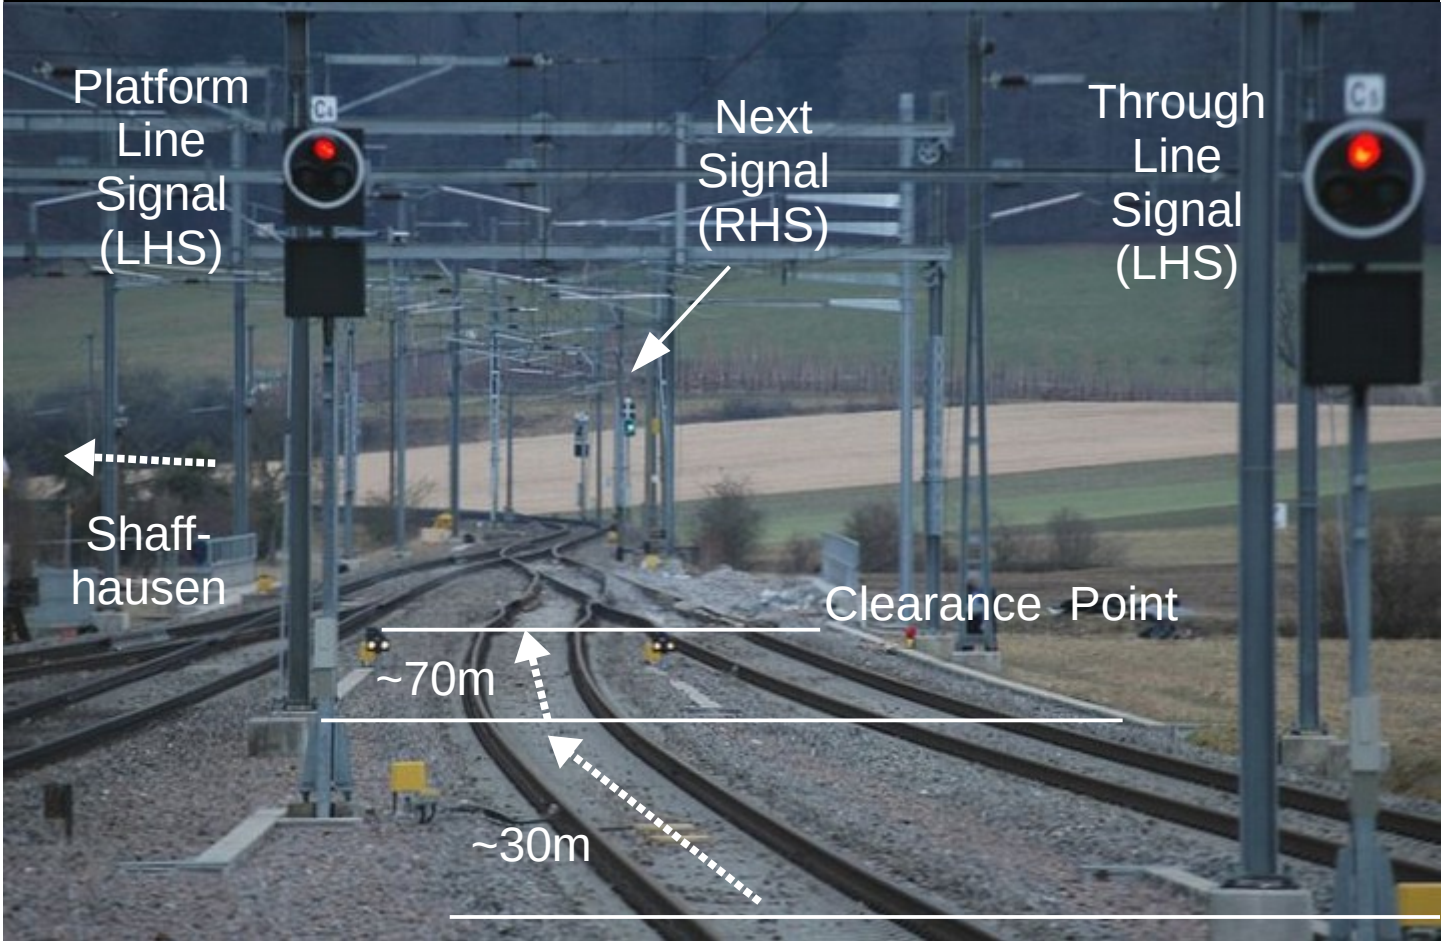
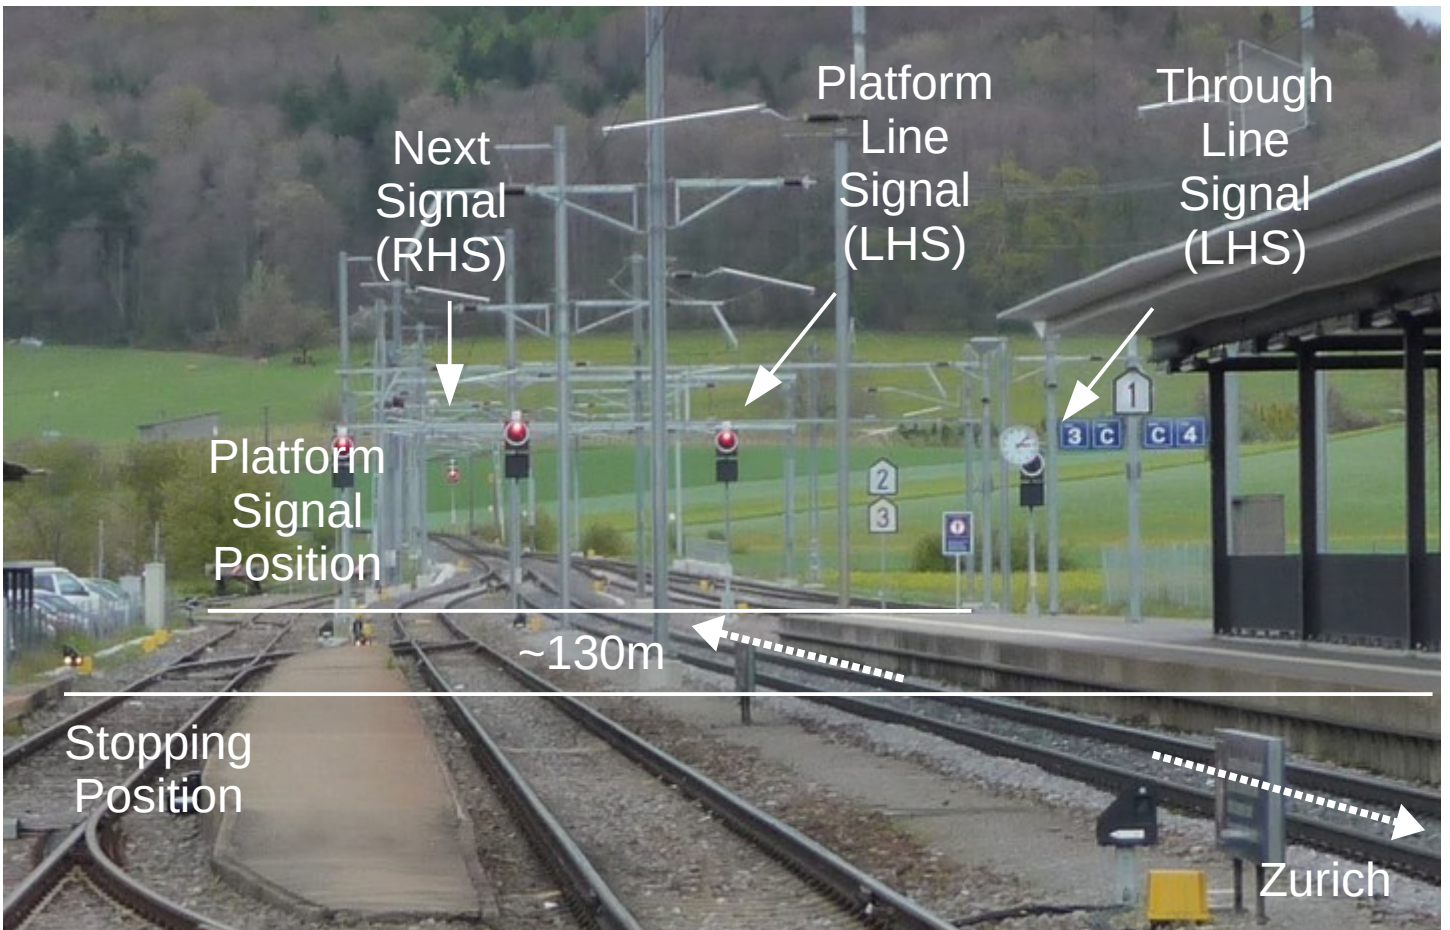
Could 'read through' to next visible signal (seen showing green above & red or yellow below) on right hand side have contributed to the mistake of the driver reading the incorrect signal on the right hand side of the platform track at the station?
